# Coliform & Coffee

KENT COUNTY  
**Health  
Department**

# Grocery Store with Retail Food Establishment

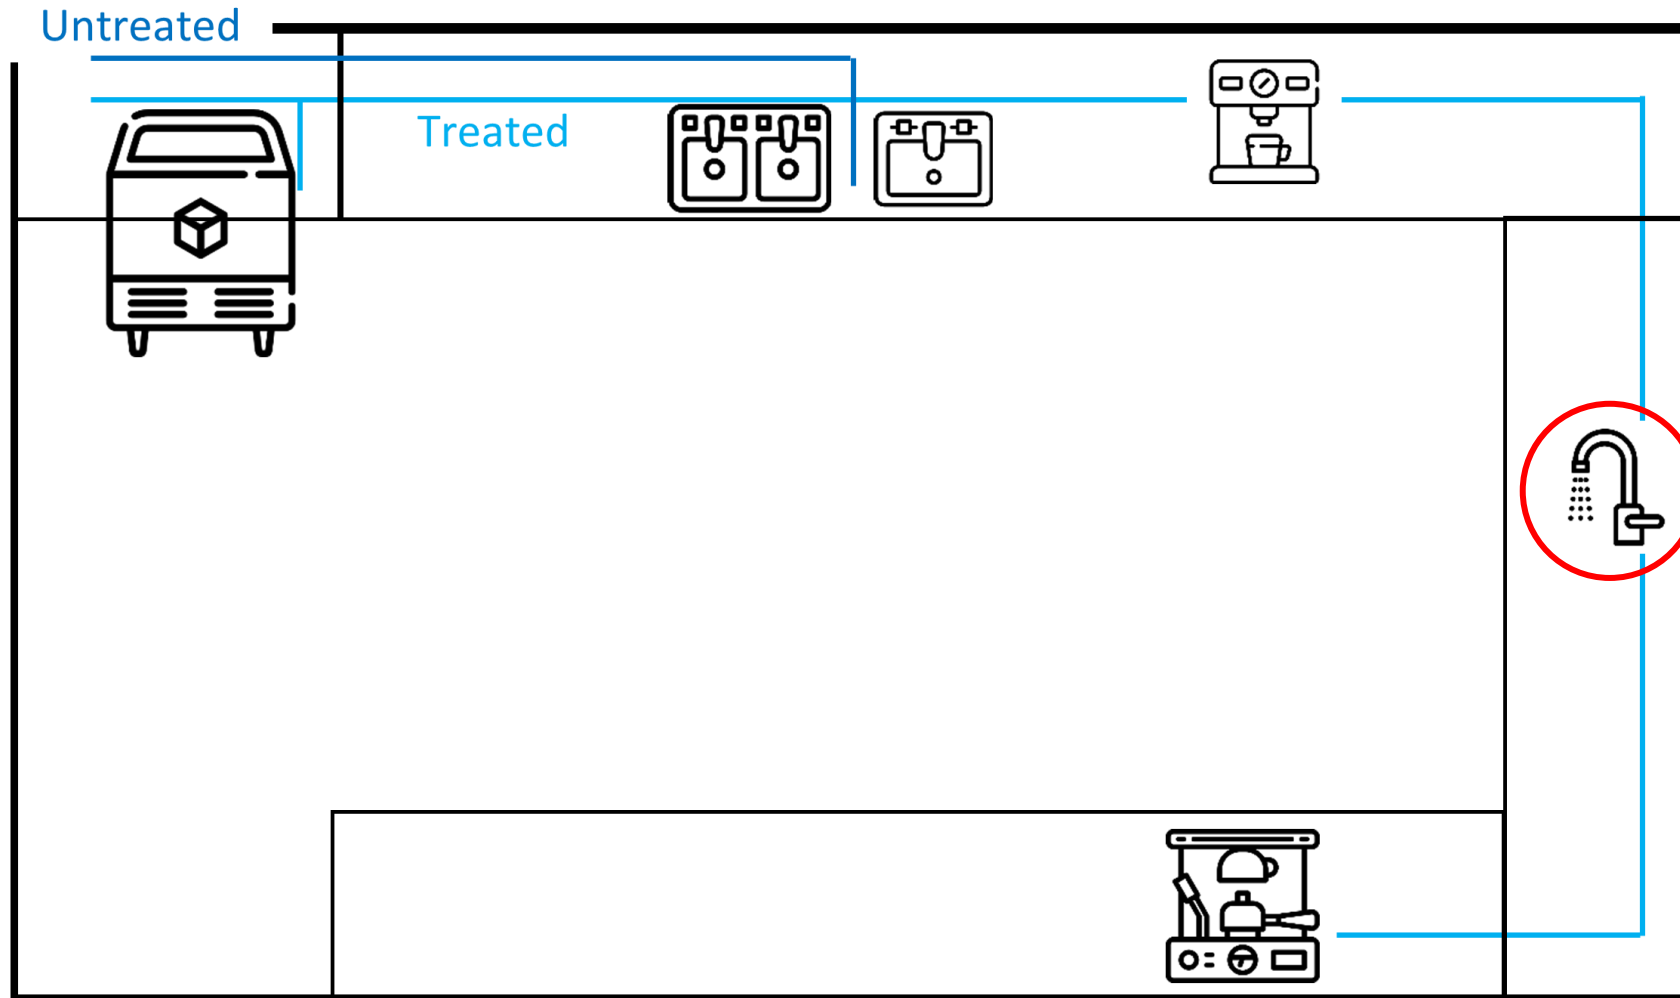
# Food Establishment Water Distribution Layout

- Store performed some remodeling in May and June 2022
  - Restroom fixtures replaced
  - Drinking fountain not in service
- Glass fill supplied by treated water
  - Drinking locations at RFE supplied with treated water (reverse osmosis)

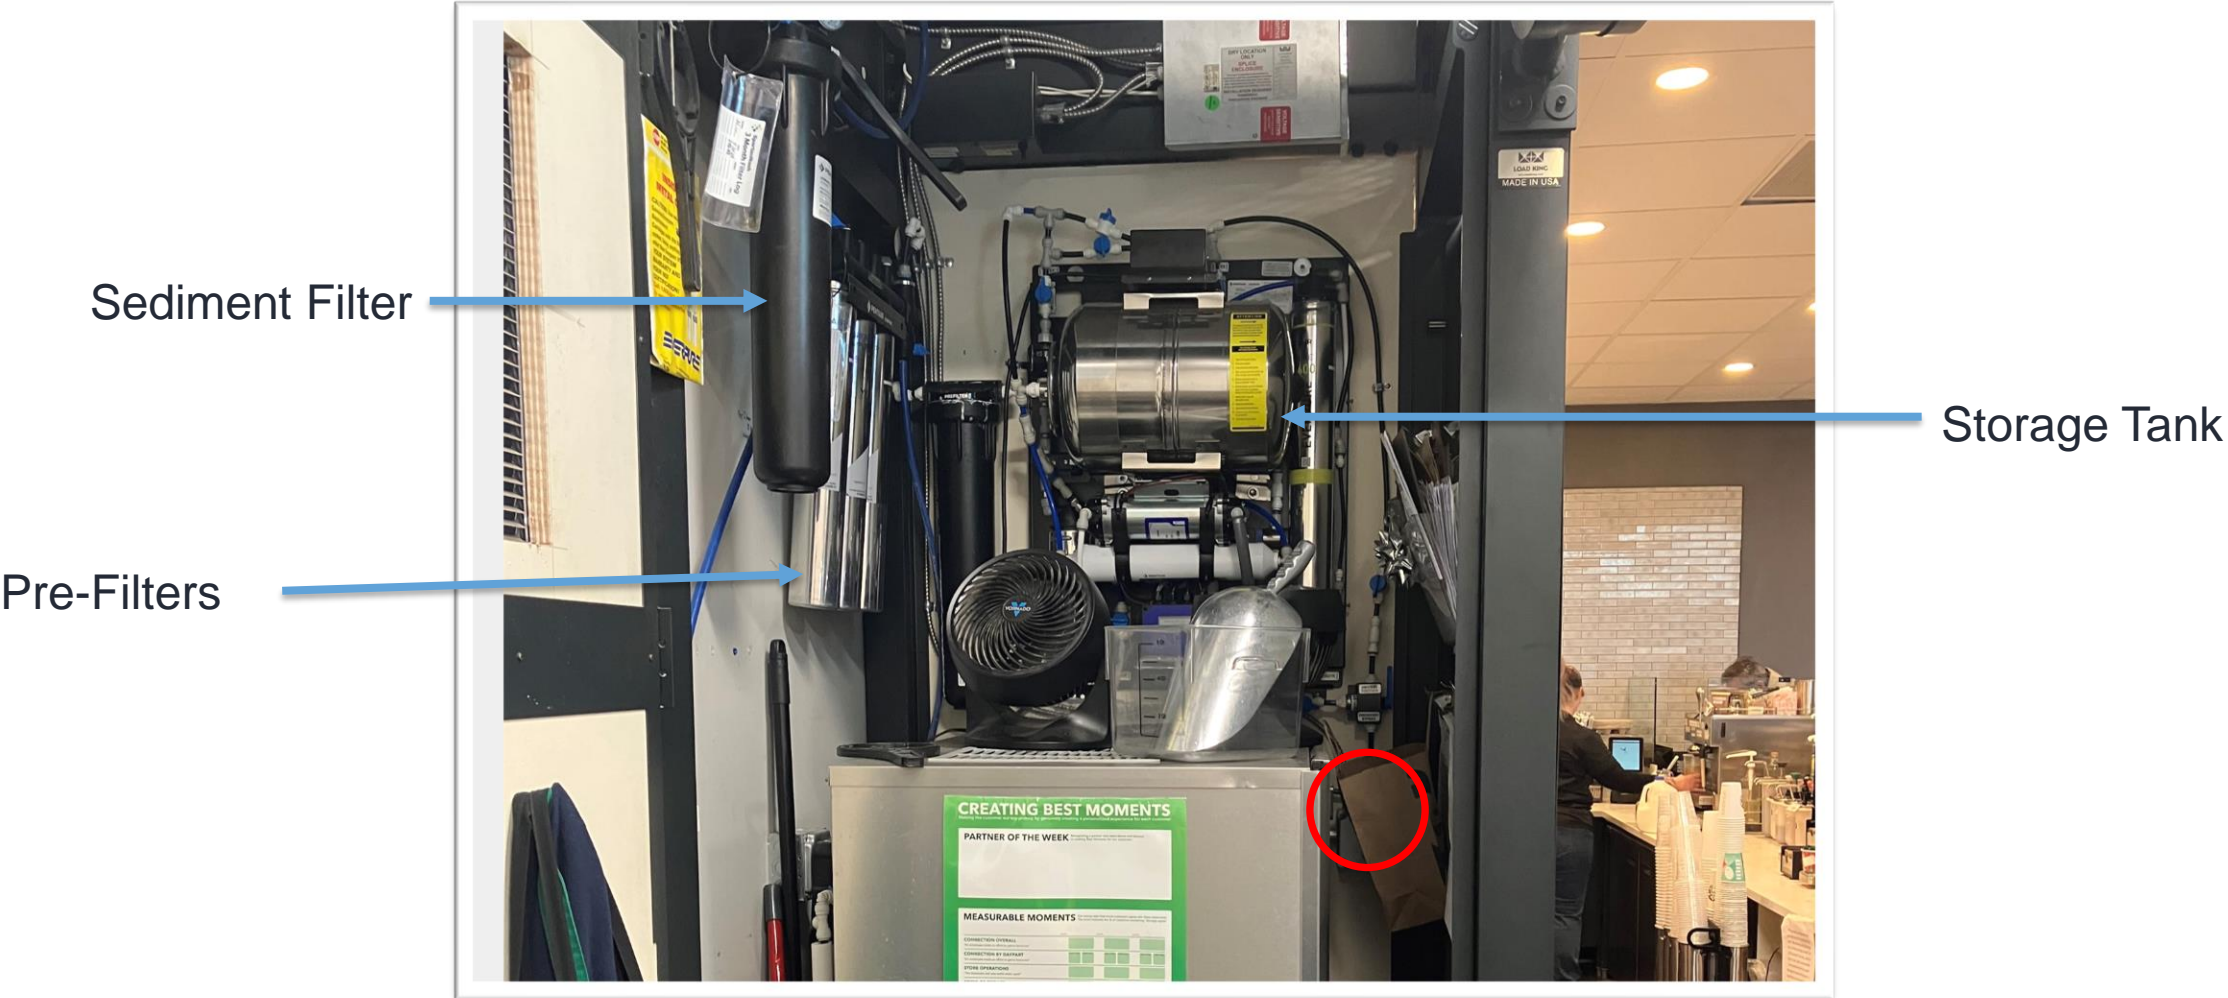
# Reverse Osmosis Treatment System

- Two (2) construction samples were collected August 11, 2022
  - After the RO: **Positive**
  - Glass fill: **Positive**

- Operator worked with water supply staff to identify other potential sources of contamination
  - Replaced pre-filters on reverse osmosis unit
  - Replaced supply lines to all treated fixtures

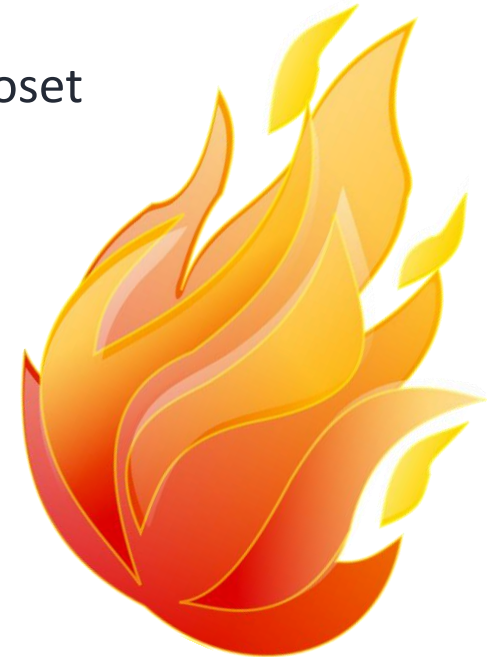
- Operator discovered exhaust from the ice machine warming the RO tank
  - Treatment unit and ice machine in small “closet”
  - Almost 100°F in closet

- Redirected exhaust from the ice machine
  - Installed vent in door
  - Installed a fan to circulate air flow
  - Insulated the RO storage tank

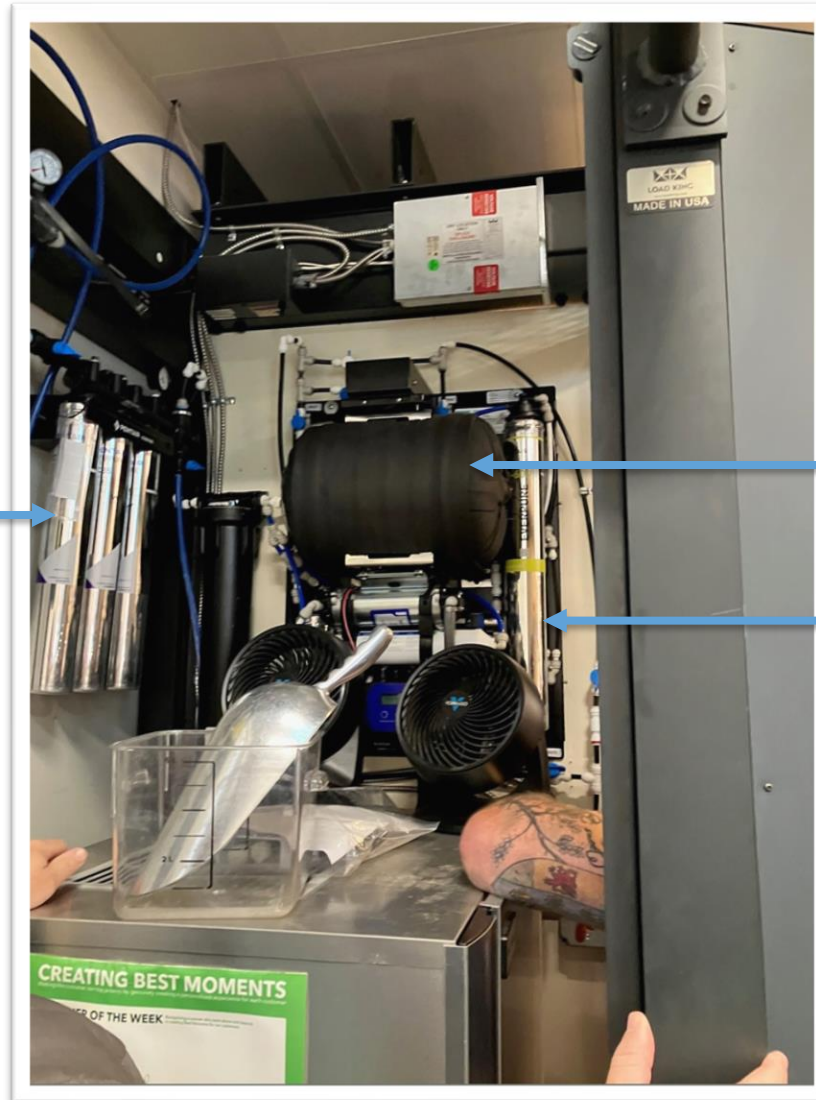
# Reverse Osmosis Treatment System

Pre-Filters

Storage Tank

Membrane Cartridge

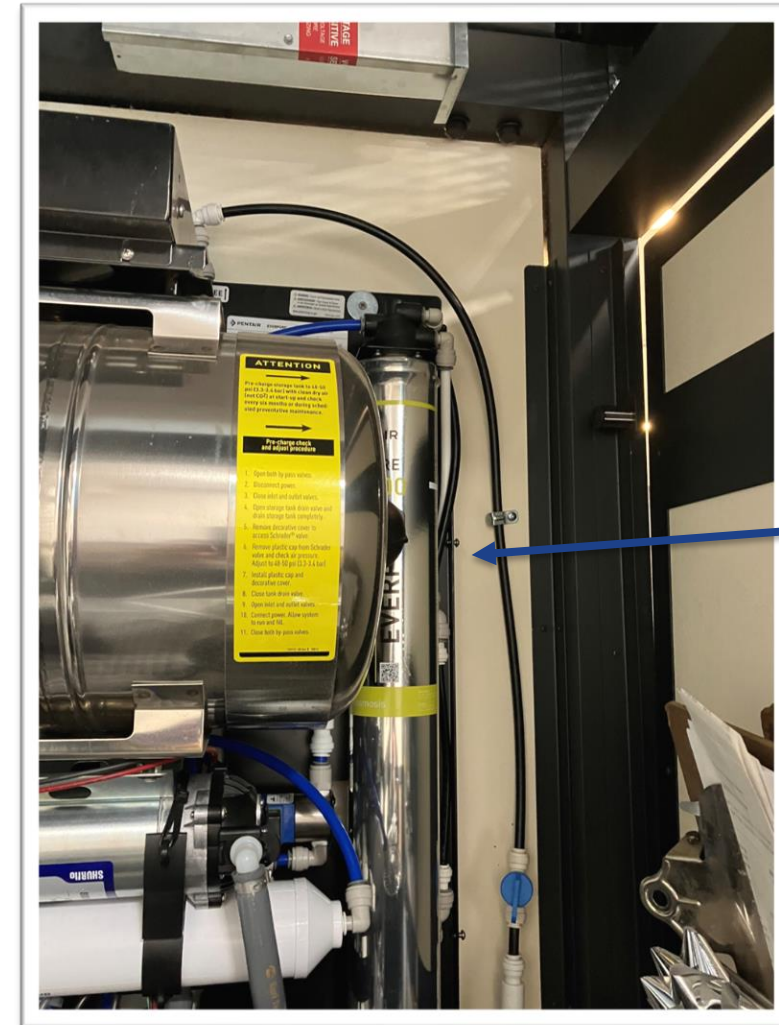
# Everpure MR-600 cartridge

Which part is the membrane filter?

Membrane Filter

- Membrane filters need to be flushed when installed to expel preservatives
- Flushing may take up to 36 hours
  - Downtime for treated water
  - Staff time
- Pentair allows select clients to purchase pre-flushed filters
  - Pre-flushed filters have a shelf life of six (6) months

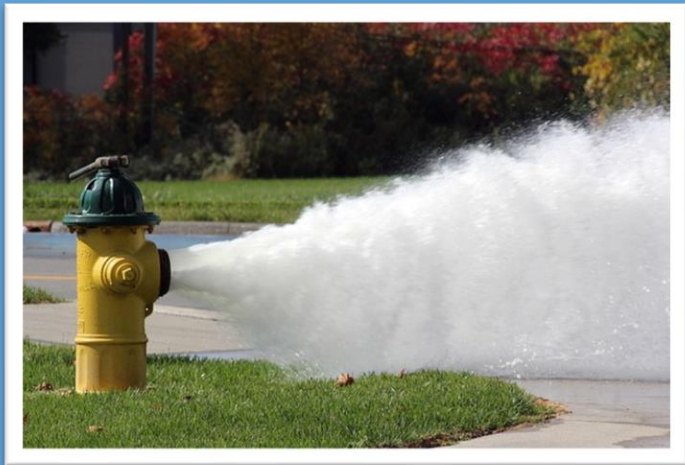
## Membrane Flushing

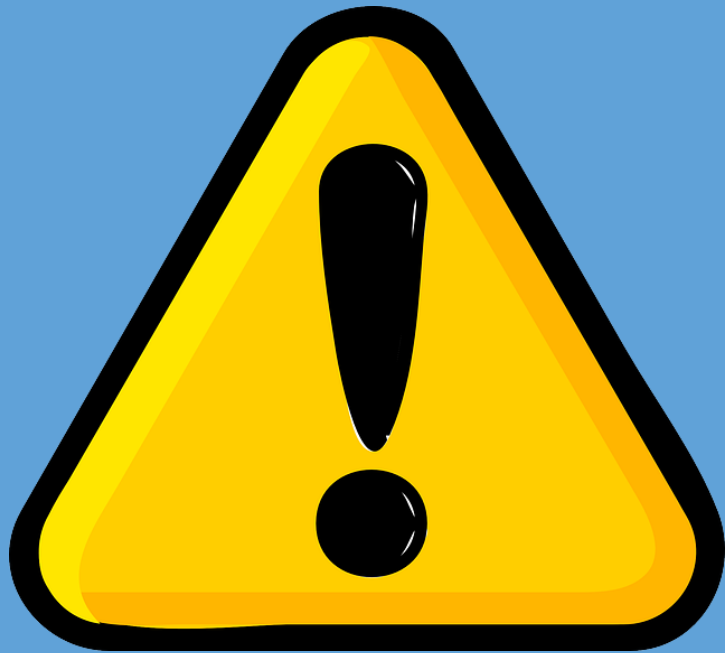
## Investigation Results

- **Found a statistically significant number of pre-flushed filters contained coliform**
  - Filters on the shelf
  - Filters recently flushed
  - Filters previously shipped
- Unflushed filters found to be unaffected
- Zero (0) samples were E. coli positive

- Pentair's records allowed for a high confidence level of customers and stores with pre-flushed filters
- Sent an "alert notification" to customers
  - Created a video with a specific customer to identify and replace affected filters
